Customer.: Subjekt.: Extension tube f. Ø60,3 – V1000 Date.: 19-10-2021 Production no.: Scale.: 1:10 Order no.: Calculation: Int.: SP/MRF Drawing. No.: ET-Ø60 V1000 Note.: Tolerance: DS/EN 1090-2 DS/ISO 2768-2-L			
This drawing is our property and must not be copied, transferred or in any way used by a third party without our written permission

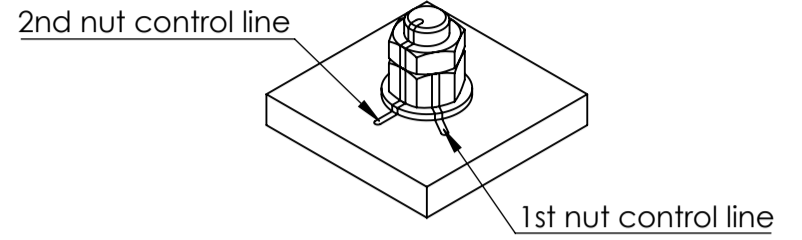
1st nut should be spanned to a tight condition.
 2nd nut should be brought at least to a snug-tight condition, with special care being given to avoid over-tightening.
 Nut-marking should be made acc. to figure after torque.

Visual inspection of bolt torque and any loose items is made 1 year after installation, and afterwards every 5th year.
 Check if the marking from bolt torque is still straight.
 Check if the corrosion protection system is satisfactory.
 Any findings must be repaired as soon as possible.
