Rev.:	Int.:	Date:		Comment					
	X	Customer.:							
		Subjekt.:	Exte	nsion tube	f. Ø76,1	- V500			
		Date.:	19-10-	2021	Production no.:		Scale.:	1:10	Format:A3
0	A/ST	Order no.:			Calculation:		Int.:	SP/MRF	Projektion:
Ca	rie	Drawing. No.: ET-Ø76 ∨500					Note.:	,	Tolerance: DS/EN 1090-2
This drawing is our property and must not be copied, transfered or in any way used by a third party without our written permission DS/ISO 2768-2-L									
Carl C	A/S M	anufacturing	Engine	ering Commerc	Smedevej 2 DK-	6900 Skjern Te	el. +45 97351	066 Fax +45 9735	51276 www.carl-c.com

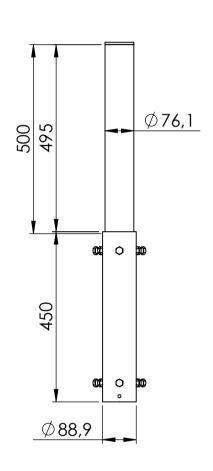
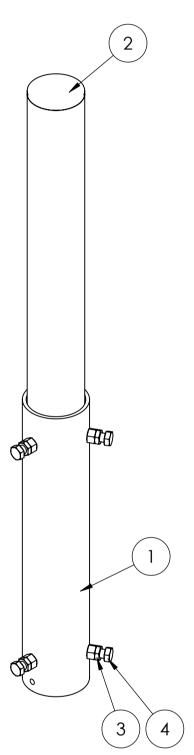
Installation:

1st nut should be spanned to a tight condition.

2nd nut should shall be brought at least to a snug-tight condition, with special care being given to avoid over-tightening. Nut-marking should be made acc. to figure after torque.

Maintenance:

Visual inspection of bolt torque and any loose items is made 1 year after installation, and afterwards every 5th year.

Check if the marking from bolt torque is still straight.

Check if the corrosion protection system is satisfactory.
